Advisory

Subject: Recommended Modification
CX4 & CX5 Nose Gear Travel Stop

Thatcher Aircraft, Inc.
1020 E. Jordan Street, Unit A
Pensacola, Florida 32503
850.715.4539
thatchercx4@cox.net

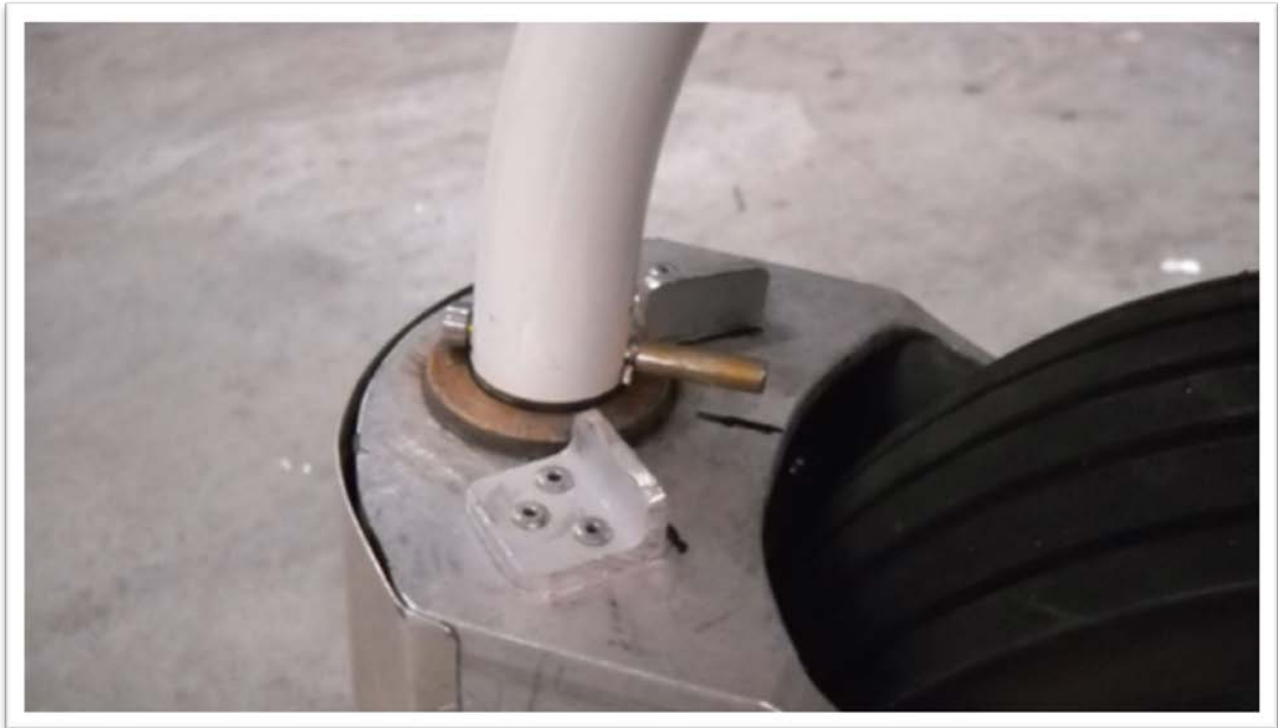
A recent event with the nose gear on CX5 001 prompted this modification that Thatcher Aircraft recommends be done on all CX4 & CX5 Tri-gear Aircraft.

A minor engine oil leak was discovered, with oil traveling down the front strut that ultimately impregnated the Belleville washer stack under the fork. This oil relieved the preload on the washer stack, and allowed a severe shimmy to occur on the front fork during taxi. The fork rotated 360° during the shimmy, and entered the prop arc. The prop and wheel pant were damaged.

To prevent this extreme rotation, a wheel stop was designed (ref photo below and attached drawing) to limit the front fork/wheel rotation to 45° left and 45° right of center.

The fork stops are 1/8" angles cut as shown. The gear leg pin is a 1/4" AN4 bolt held in place with a 1/16" cotter pin.
