# Advisory

**Subject:** Recommended Modification  
CX4 & CX5 Tail Wheel Spring Mount

**Thatcher Aircraft, Inc.**  
1020 E. Jordan Street, Unit A  
Pensacola, Florida 32503  
850.712.4539  
thatchercx4@cox.net

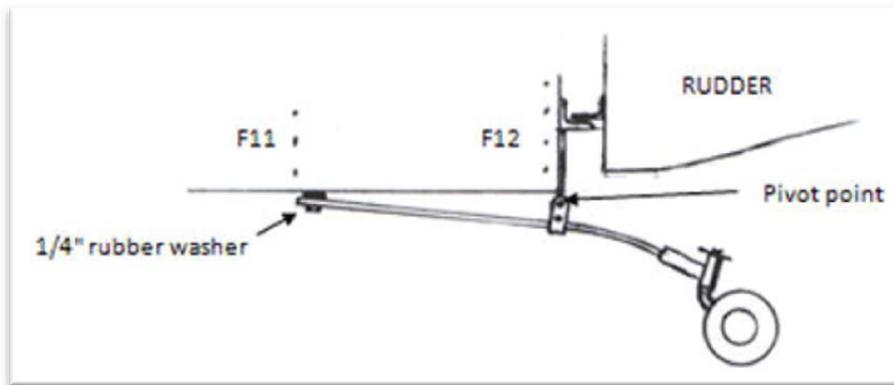
It was reported on February 26, 2015 that during a routine condition inspection of a CX4 with 485 hours of rough sod field operation, cracks were found on the F12 bulkhead where the tail wheel bracket attaches.

After investigation, cracks were found on the F12 bulkhead and lower skin due to a rocking action of the 3/16" x 1-1/2" mount angle for the tail wheel spring.

It is our recommendation to remove the angle and replace with the bracket shown in the drawings and photos in this advisory. This bracket allows the tail wheel spring to pivot without placing a load on the F12 bulkhead and lower skin.
